**Docket No. 217 – Development and Management Plan Inspection**

Northeast Utilities Service Company Certificate of Environmental Compatibility and Public Need for the construction of a 345-kV electric transmission line and reconstruction of an existing 115-kV electric transmission line between Connecticut Light and Power Company's Plumtree Substation in Bethel, through the towns of Redding, Weston, and Wilton, and to the Norwalk Substation in Norwalk, Connecticut.

**Date:** June 22, 2005

**Location:** 115 kV Underground Route

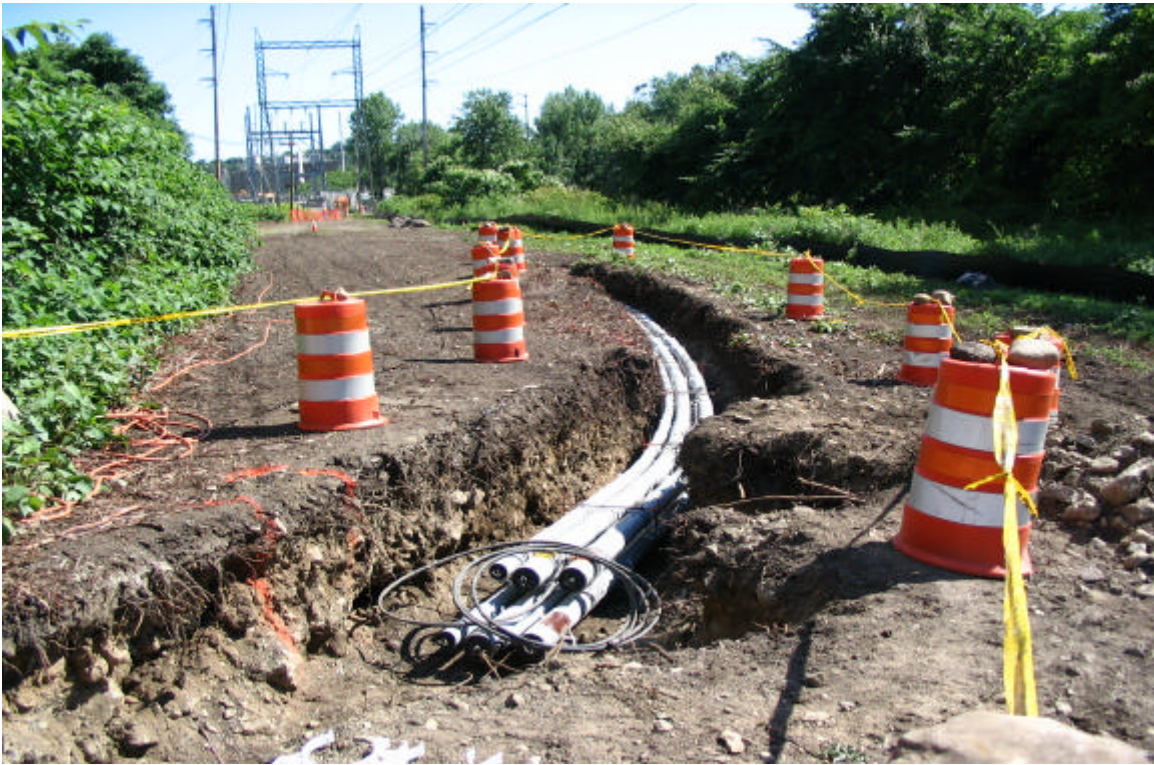
115 kV (Broad Street-Norwalk)- Conduit installation has been completed from the edge of the substation leading to Broad Street and the ROW is well restored. 6/22/05

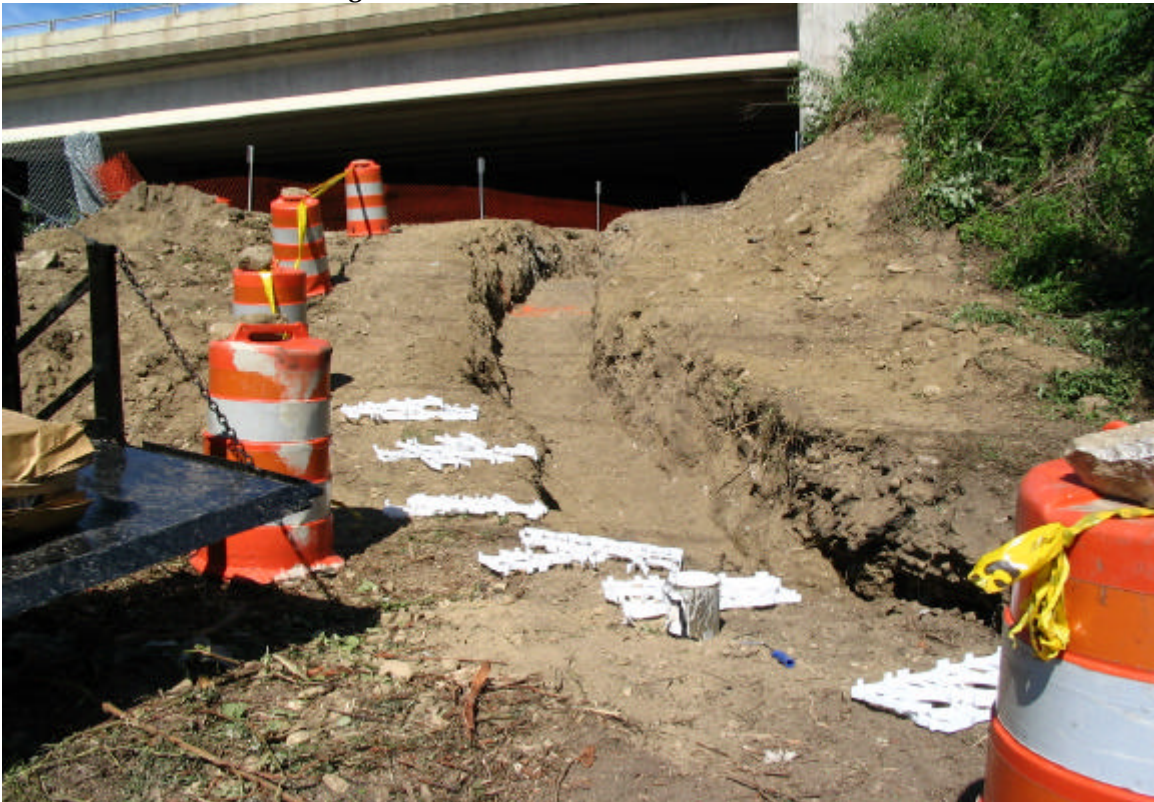
Trench work leading from the ROW to the shoulder of Broad Street. Conduit work is almost ready to leave the ROW here. 6/22/05

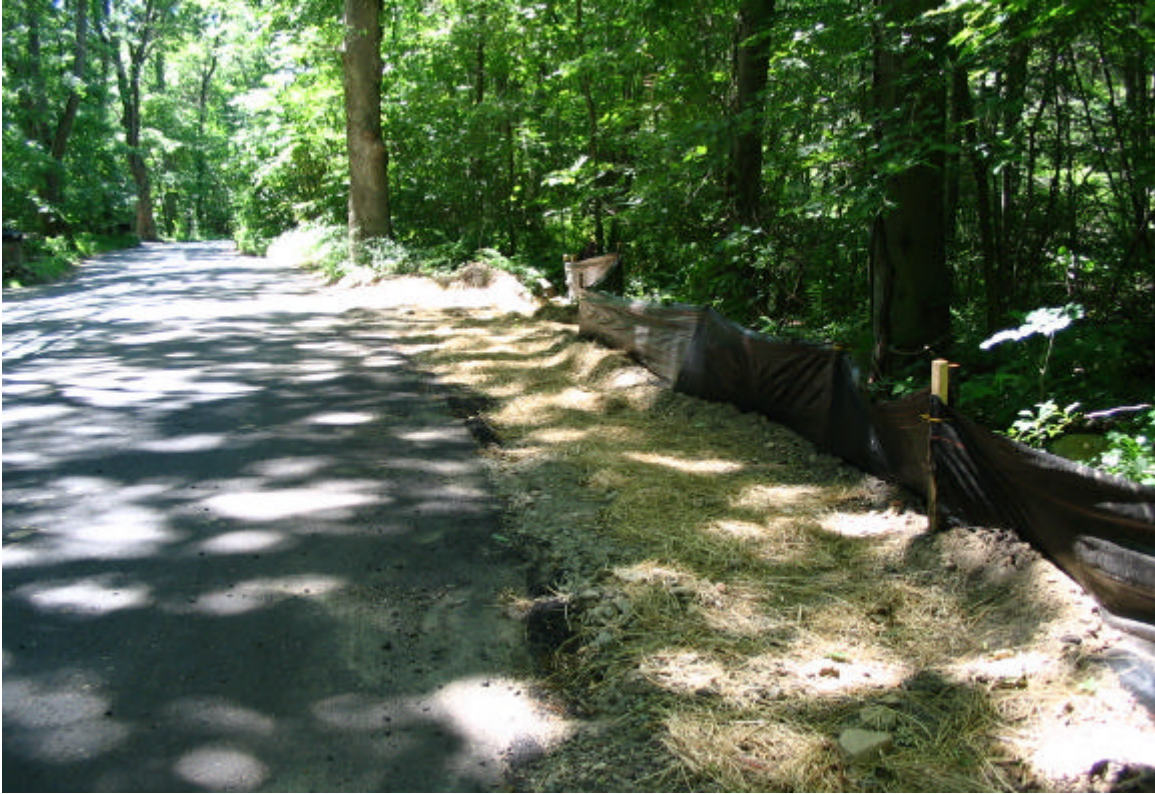
**115 kV (Gallows Hill Road, Redding)-View of the completed vault #13. The silt fence was restored and the area mulched with hay. 6/22/05**

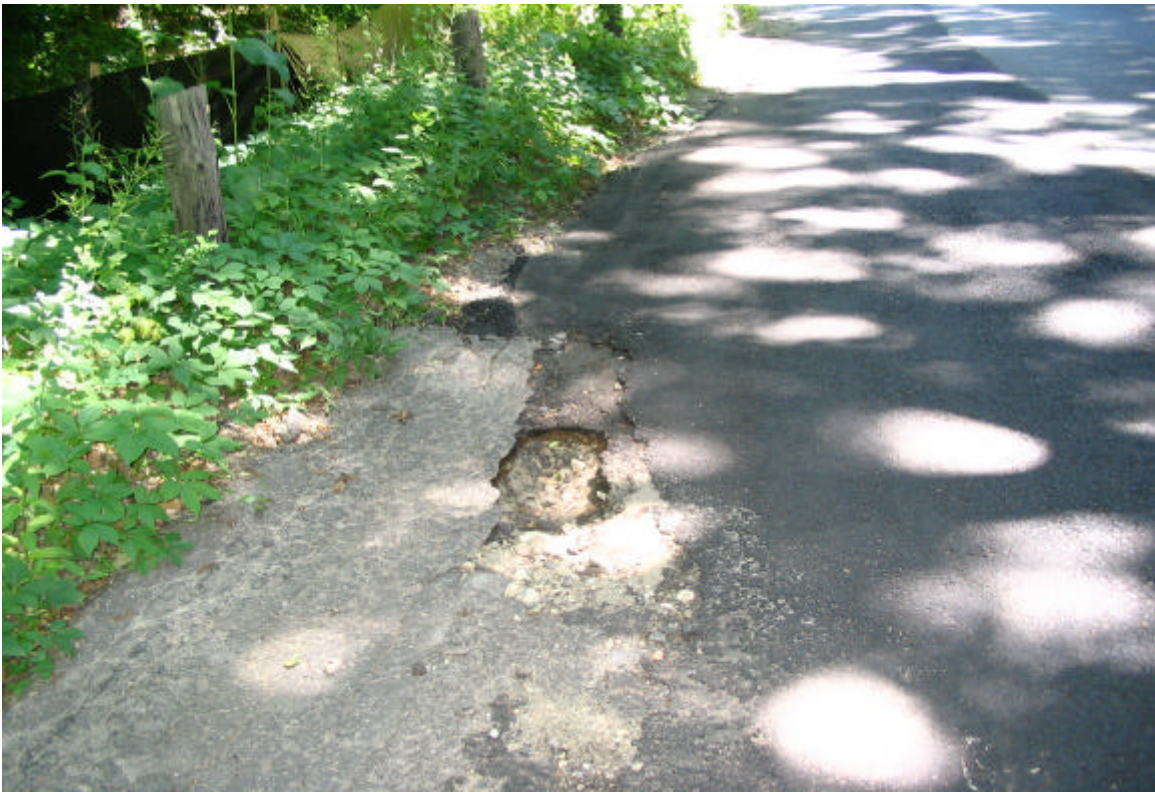
**Some erosion in the edge of the trench asphalt was noted in a few locations east of Longwood Drive on Gallows Hill Rd. The potholes will be filled with asphalt. 6/22/05**

<b>Gallows Hill Road and Rt. 107 (Lonetown Rd)</b>	<p>-Vault installation on Gallows Hill is complete. The area adjacent to completed vault #13 was mulched with hay and silt fence repaired. 6/22/05</p> <p>- All silt fence associated with the Gallows Hill ductwork/ installation areas were well installed. 6/22/05</p> <p>- Some erosion/deep potholes were noted in the asphalt along the edge of the completed trench cover east of Longwood Drive. 6/22/05</p>	<p>- Most erosion controls along Gallows Hill are in good repair. The pull off area near completed vault #15 still has a pile of stone off the roadway against the silt fence and other trench components left here. This area should be cleaned up when feasible 6/22/05.</p> <p>- Asphalt will be placed here to repair the potholes. 6/22/05</p>

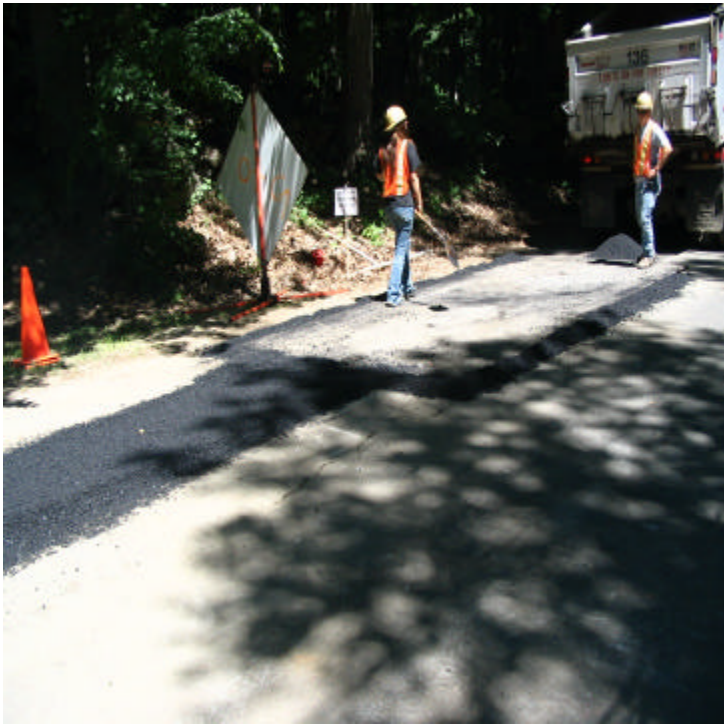
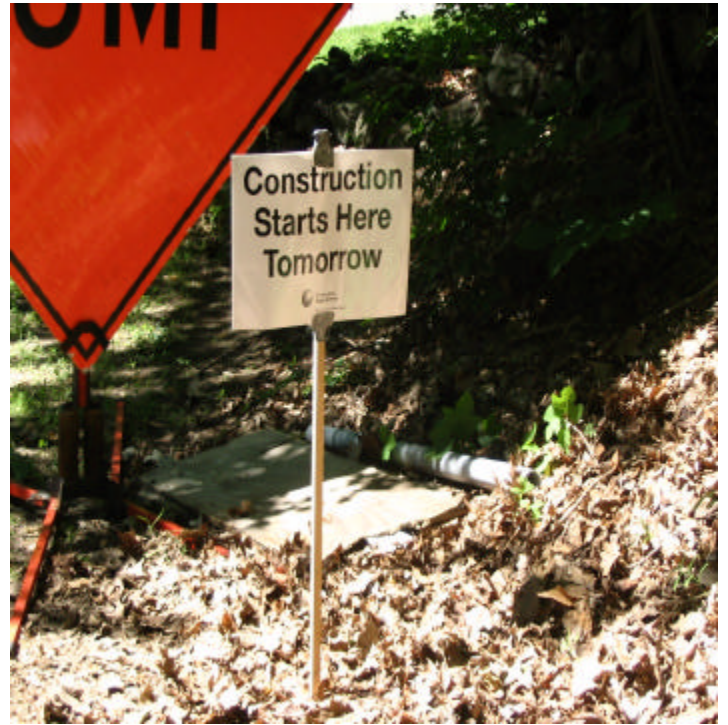
View of the day's finished trench cover and paving along Gallows Hill Road near house #96-109.  
6/22/05

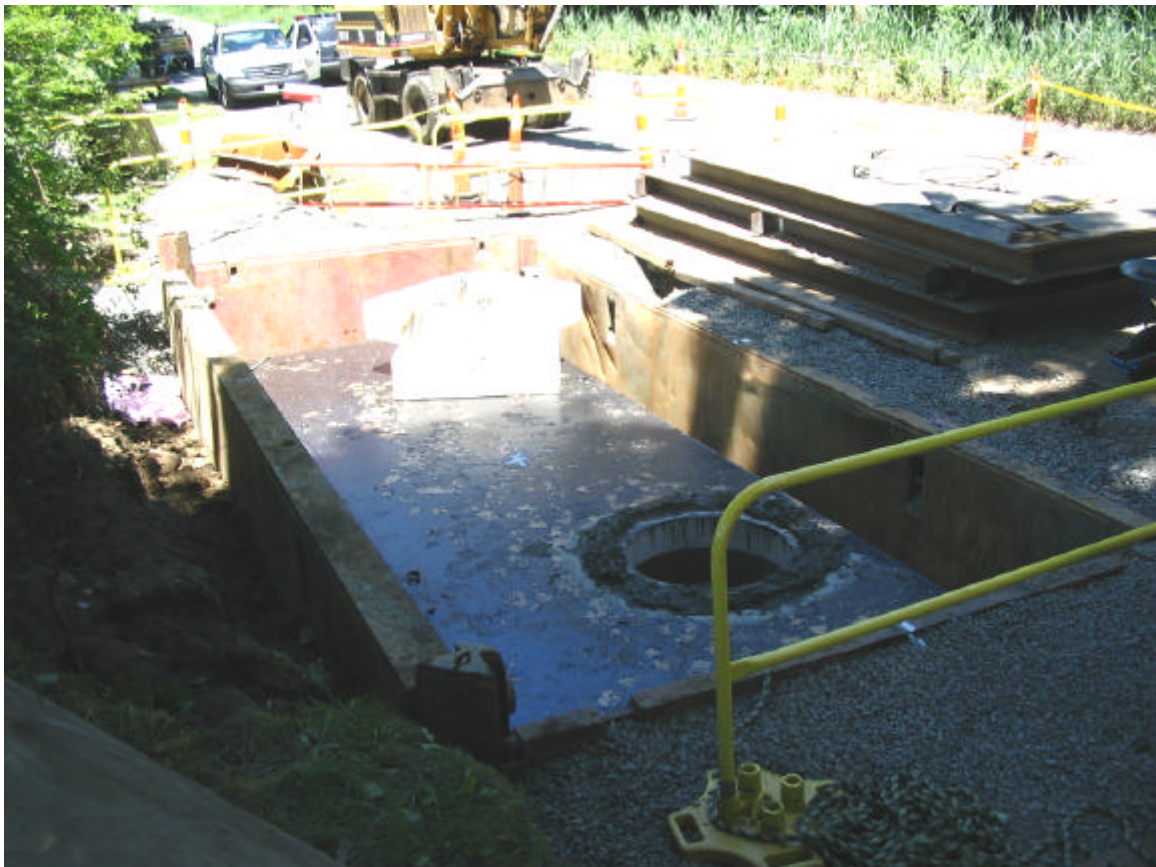
115 kV (Route 107, Redding)-View of the recently installed vault #12 along Rt. 107 south of  
Gallows Hill Rd. 6/22/05

- Several locations along Rt. 7 are being trenched at this time but almost all adjacent areas are highly developed commercially. 6/22/05	- None at this time. 6/22/05
Contaminated Soils	- The vault #12 installation is in one of the areas flagged as having contaminated soil along Lonetown Rd. Soil is being stored and labeled separately from that considered “background polluted” and both types are brought off site to an O&G facility in Bridgeport. Water from these soils are sent to a tank truck. 6/22/05	- It should be determined whether the “polluted” soils exceed the levels approved as daily cover for the landfill if the Town of Redding is still interested in obtaining it. 6/22/05
Adjacent Wetlands and Waterways	-None of the wetland resource areas adjacent to the roadway work were affected by the activities in any of the locations. No sedimentation or turbidity was noted. 6/22/05	-None at this time. Continue to monitor.

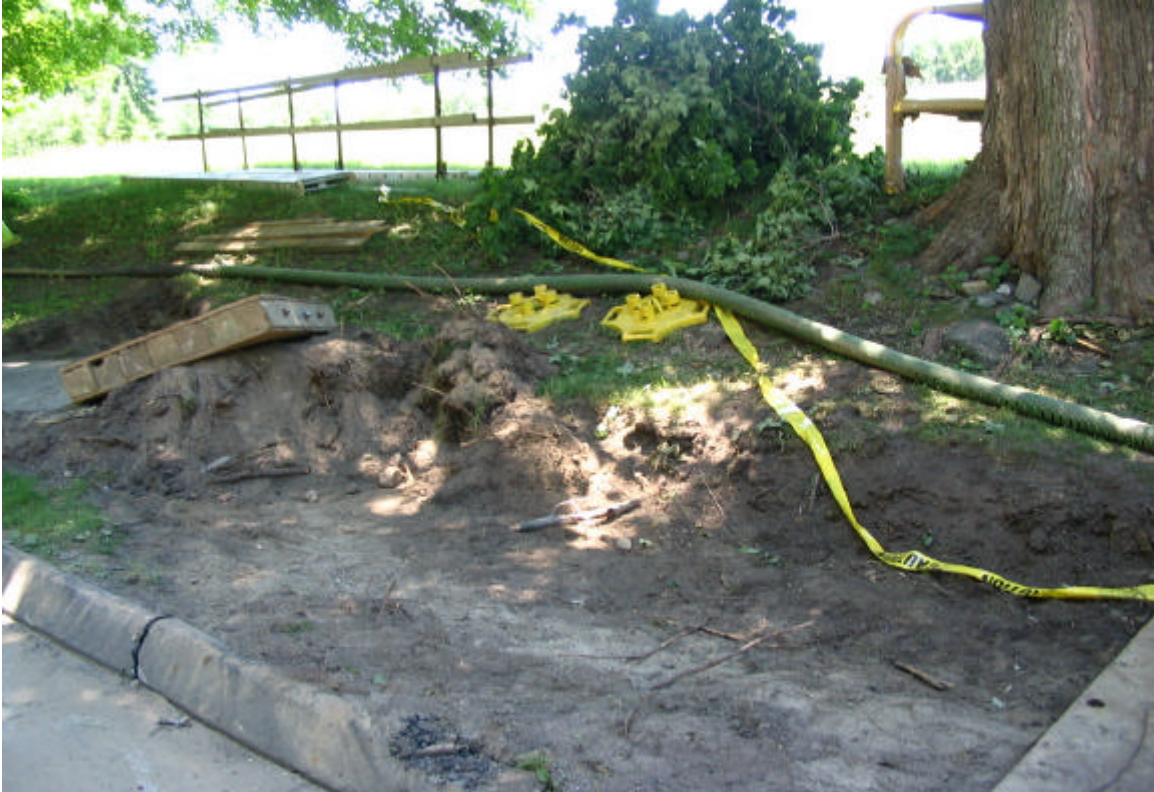
View of the shoulder of Rt. 107 adjacent to the vault installation. It appears that major roots of the shade tree were avoided. The area should be restored temporarily. 6/22/05

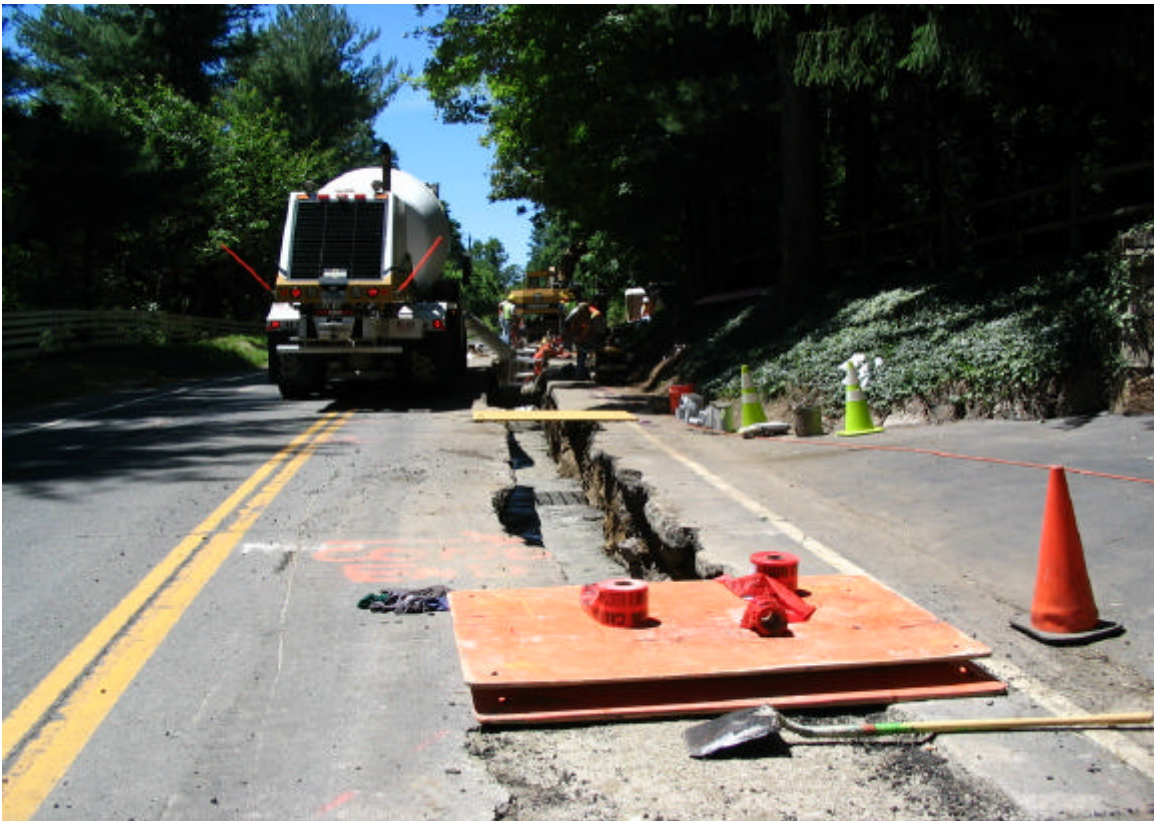
Trench work continues to the north of Putnam Park in the roadway of Rt. 107. 6/22/05

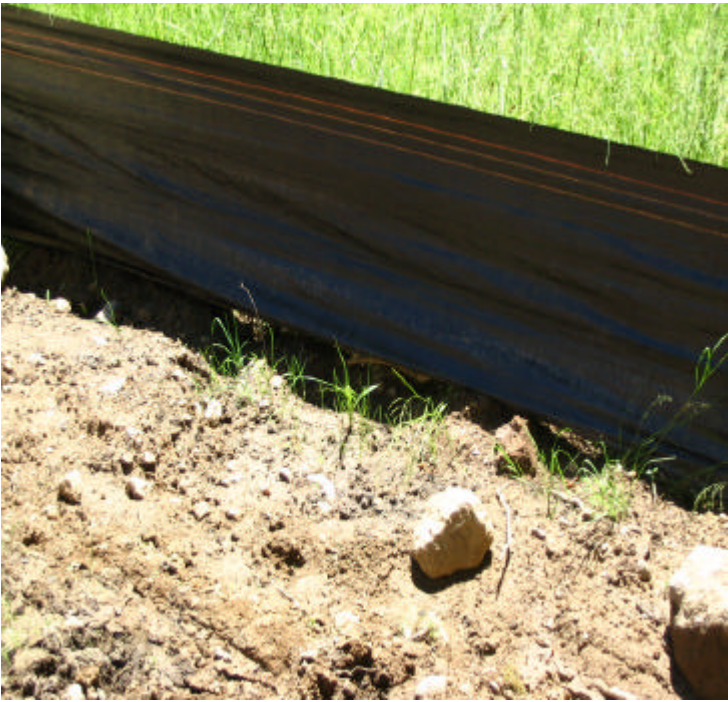
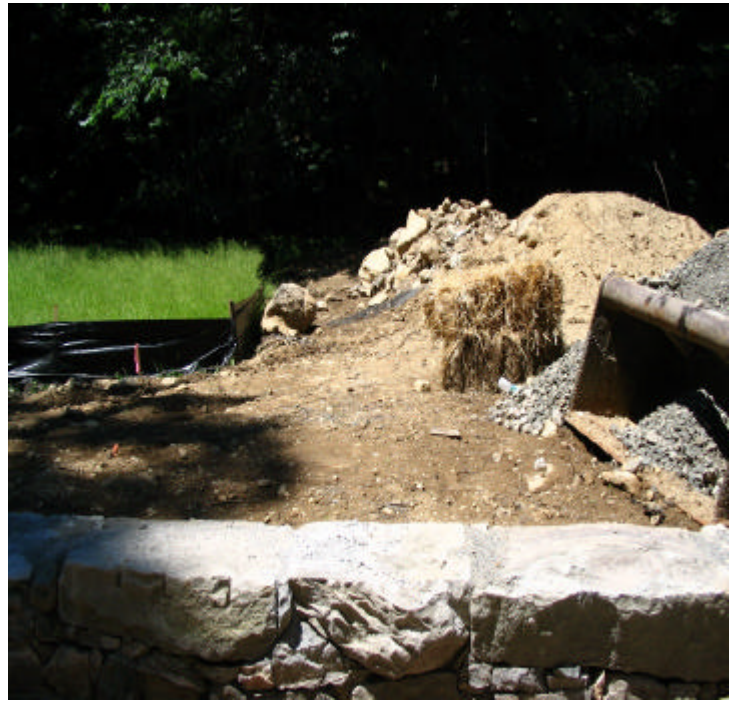
New silt fence was installed along the storage area at Putnam Park (Rt 107) however it was not toed in. Silt fence should be toed in several inches or it will not filter run-off as it is intended.

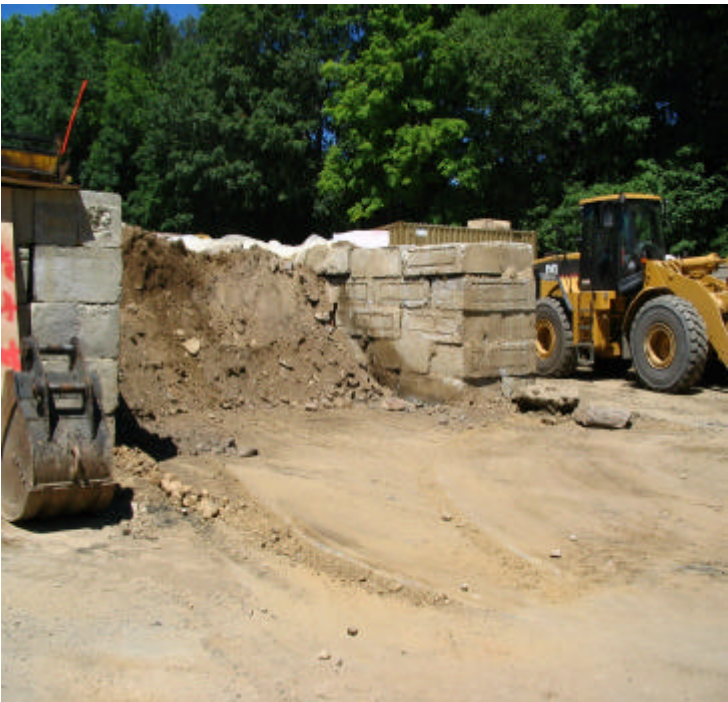
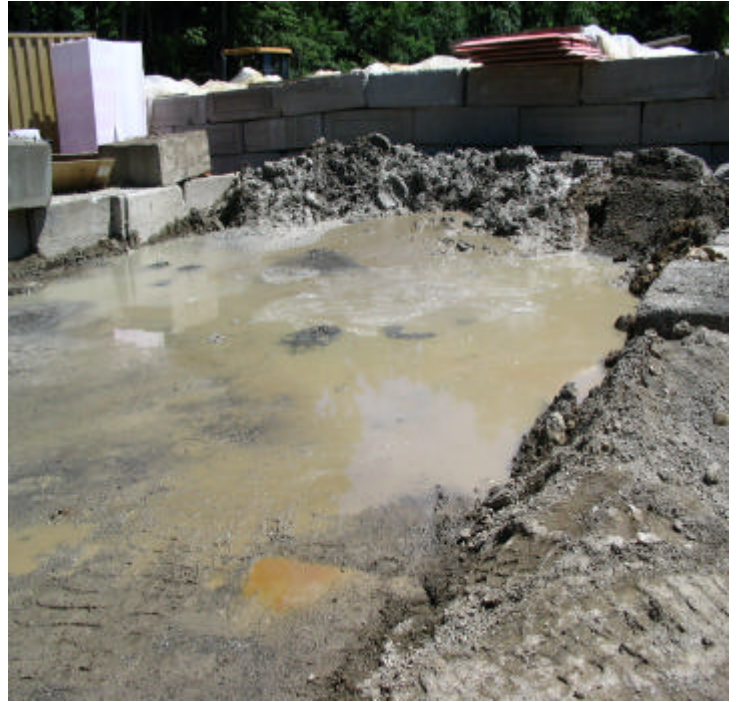
The Redding Town Yard: The excavate is being trucked to the O&G Bridgeport facility for disposal and only temporary piles remain. The concrete washout area has been cleaned out and bermed and water is no longer escaping. 6/22/05

Areas of Inspection	Observation	Recommended Action
	<p>excavate is only temporarily stored here until it can be trucked for disposal in the O&amp;G facility in Bridgeport. Soil considered "background polluted" is kept separately from that considered contaminated. The soil piles here are not very large at this time. 6/22/05</p> <p>- Concrete washouts are also taking place within the yard in a specified location. The area was recently cleaned out and bermed up and this prevents washing to the catch basin on site. 6/22/05</p> <p>- The <b>Putnam Park parking lot</b> is also being used for temporary equipment storage and includes small sand/stone piles and some machinery. 6/09-6/22/05</p>	<p>the bins, haybales should be placed downgradient of the pile unless this is in the way of active equipment movement. 6/15/05</p> <p>- The berm solution is very good and the washout area was well contained at the time of inspection. It should be emptied regularly to prevent escape of the wash water. 6/22/05</p> <p>- Although the area has disturbed soil due to a separate project at the park, it should be monitored since it is being used for the 115kV project. 6/22/05</p>
